Manhole Inspection Summary

Manhole # S27A__031MH

Insp Date: **11/28/07 11:03 AM**

Location Address: **715 FREMONT AVE**

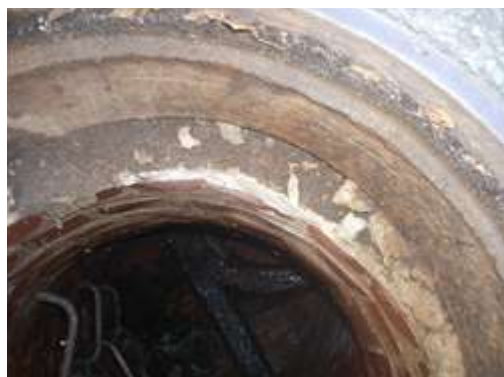
Defect 1

Offset: **3** (in.)

FRAME OFFSET

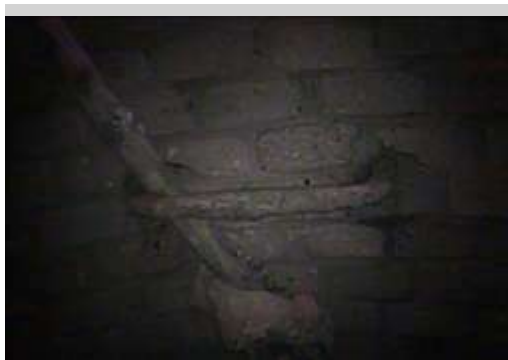
Defect 3

Count: **7** Missing: **0** ☒ **Corroded**

☒ **Evidence Of Surcharge** Depth: **1.5** (ft.) ☐ Active Surcharge Present

CORRODED BOTTOM STEP AND
SURCHARGE EVIDENCE ON ROD

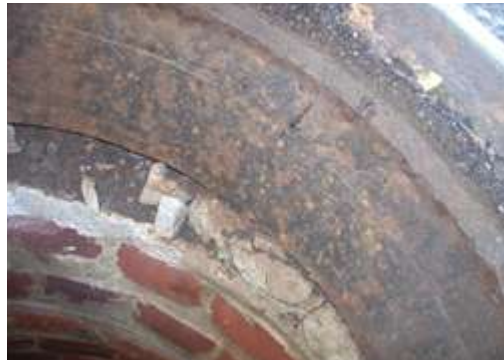
Defect 2

Condition: ☐ Sound ☐ Cracked ☐ Root Intrusion ☐ Loose Brick ☒ **Deteriorated**

CHIMNEY DETERIORATION

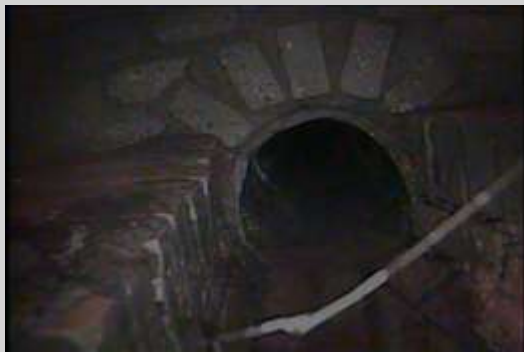
12 O'Clock Outflow

Pipe Height: **8.4** (in.) Rod and Bar (Angled)
Pipe Material: **Clay** ☐ Pipe Lined
Invert Depth: **11.10** (ft.) Flow Characteristics: **Slow**
Deposits: ☒ None ☐ Mud ☐ Sludge ☐ Debris ☐ Grease
Silt Depth: (in.) Deposits Extent:
Infiltration: **None** Pipe Seal Cond: **Sound**

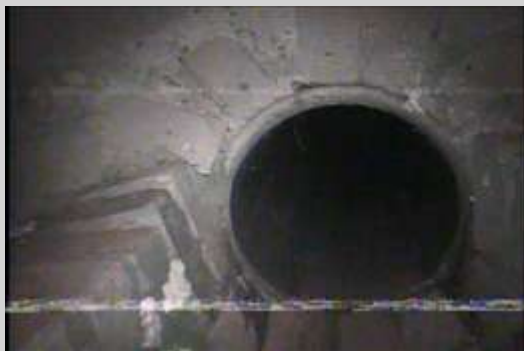
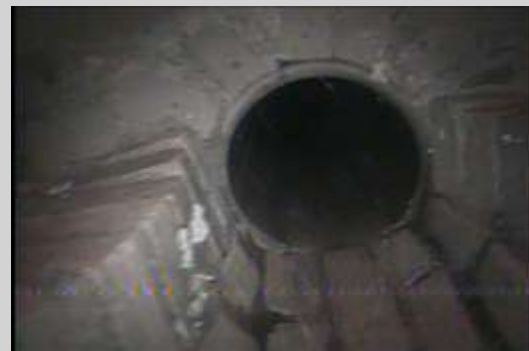
3 O'Clock Inflow

Pipe Height: **8.4** (in.) Rod and Bar (Angled)
Pipe Material: **Clay** ☐ Pipe Lined
Invert Depth: **10.68** (ft.) Flow Characteristics: **Slow**
Deposits: ☒ None ☐ Mud ☐ Sludge ☐ Debris ☐ Grease
Silt Depth: (in.) Deposits Extent:
Infiltration: **None** Pipe Seal Cond: **Sound**

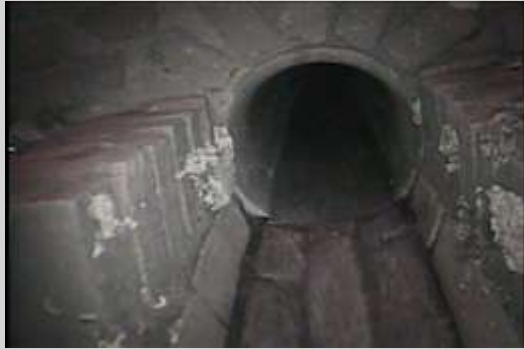
6 O'Clock Inflow

Pipe Height: **8.4** (in.) Rod and Bar (Angled)

Pipe Material: **Clay** ☐ Pipe Lined

Invert Depth: **10.84** (ft.) Flow Characteristics: **Slow**

Infiltration: **None** Pipe Seal Cond: **Sound**
